# Manhole Inspection Summary

Manhole # S11GG1002MH

Insp Date: **5/22/07 2:10 PM**

**Location** Address: **4316 BOARMAN AVE**

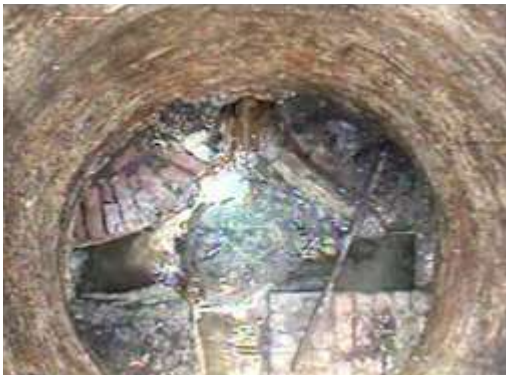
Defect 1

DEBRIS ON BENCH

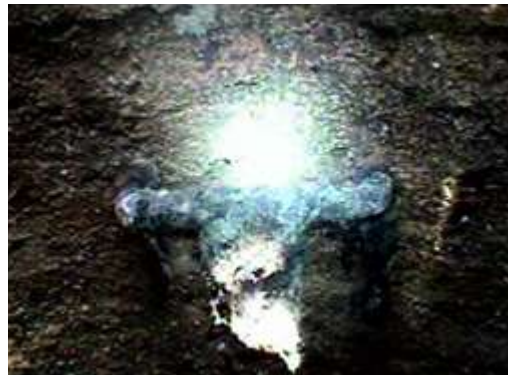
Defect 2

☒ **Evidence Of Surcharge** Depth: **2** (ft.) ☐ Active Surcharge Present

EVIDENCE OF SURCHARGE

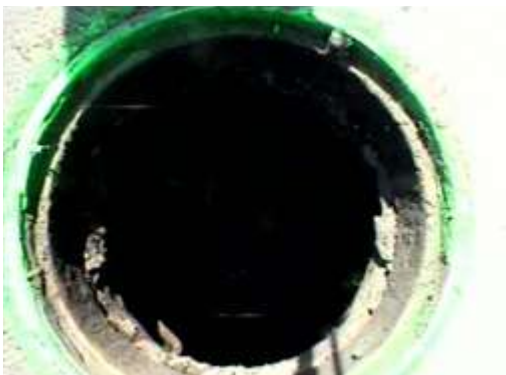
Count: **2** Missing: **0** ☒ **Corroded**

CORRODED STEPS

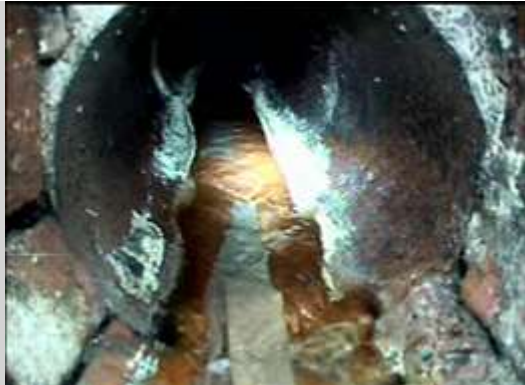
12 O'Clock Outflow

DEBRIS IN CHANNEL

Pipe Height: (in.) Direct  
Pipe Material: **Clay** ☐ Pipe Lined  
Invert Depth: **8.11** (ft.) Flow Characteristics: **Slow**  
Deposits: ☒ None ☐ Mud ☐ Sludge ☐ Debris ☐ Grease  
Silt Depth: (in.) Deposits Extent:  
Infiltration: **None** Pipe Seal Cond: **Sound**

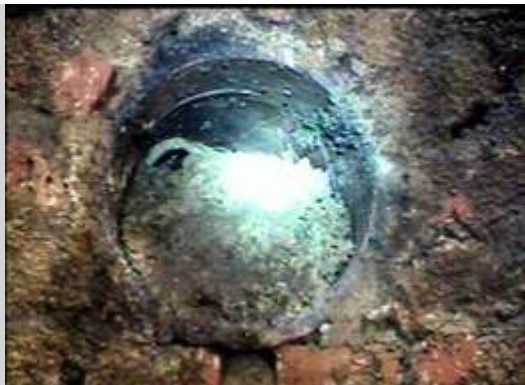
3 O'Clock Inflow

DEBRIS IN CHANNEL

Pipe Height: (in.) Direct  
Pipe Material: **Clay** ☐ Pipe Lined  
Invert Depth: **4.77** (ft.) Flow Characteristics: **Slow**  
Deposits: ☐ None ☐ Mud ☒ Sludge ☒ Debris ☒ Grease  
Silt Depth: **5** (in.) Deposits Extent: **Heavy**  
Infiltration: **None** Pipe Seal Cond: **Sound**

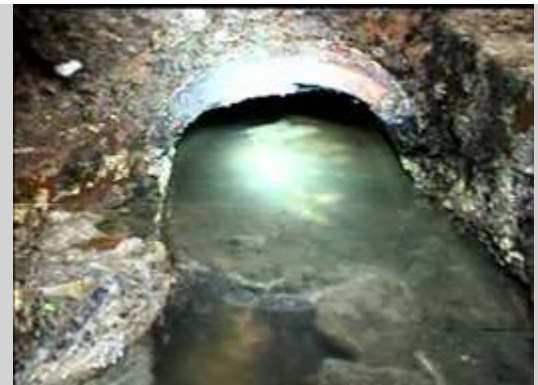
Drop In @ 3 O'Clock

DEBRIS IN CHANNEL

Drop: **Outside Direct**  
Angled: Reading: (ft.)  
Inv Depth: **7.69** (ft.)

Drop Condition: **Open**

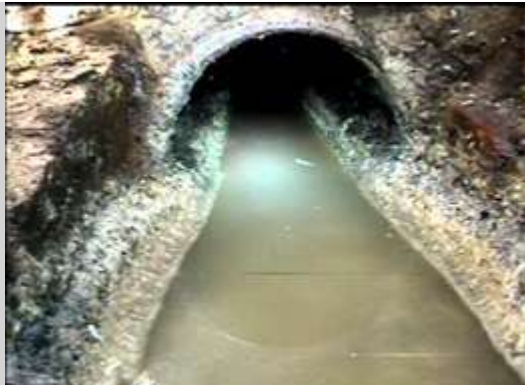
6 O'Clock Inflow

DEBRIS IN CHANNEL

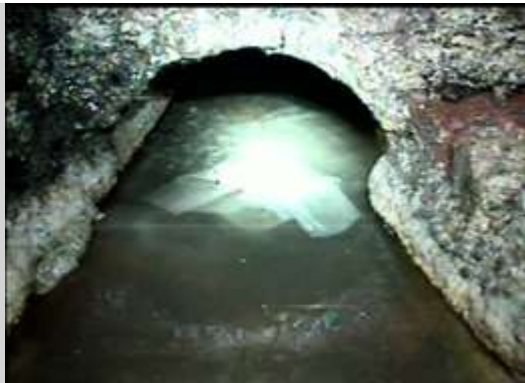
9 O'Clock Inflow

DEBRIS IN CHANNEL

Infiltration: **None** Pipe Seal Cond: **Cracked**
